Thermography and motor-condition monitoring at a paper mill

Testing Functions Case Study

Application Note

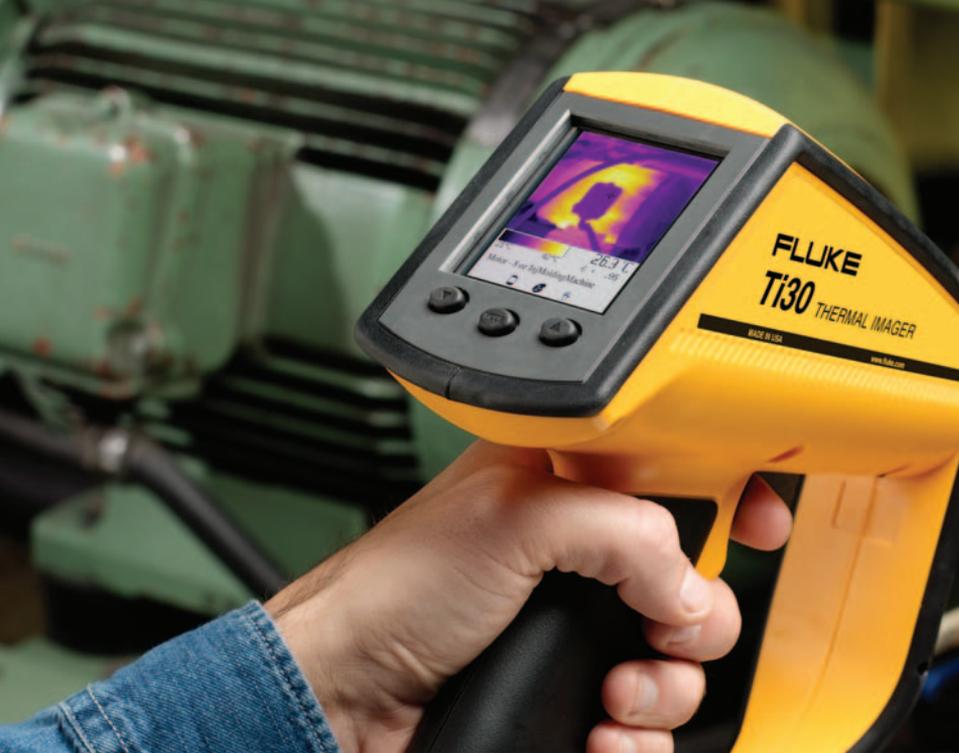
Hot connections.
