Keeping Whistler/Blackcomb up and running

Application Note

Testing Functions Case Study

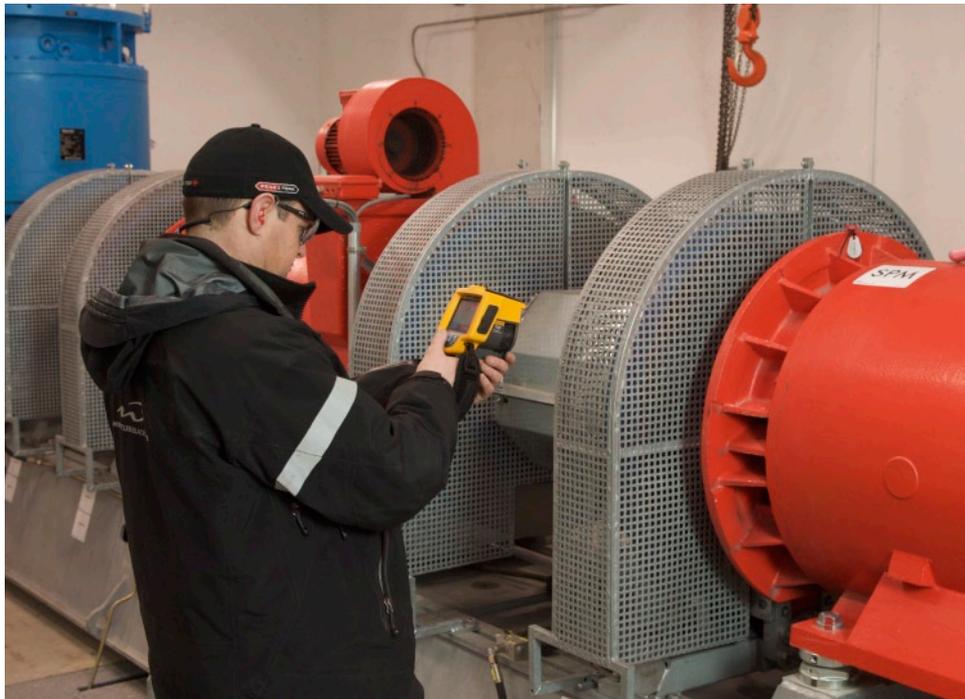
Rob Withey uses a Fluke thermal imager to check temperature on bearings and gearbox housings on the 335 kW (450 hp) motors in the Peak 2 Peak main drive room.

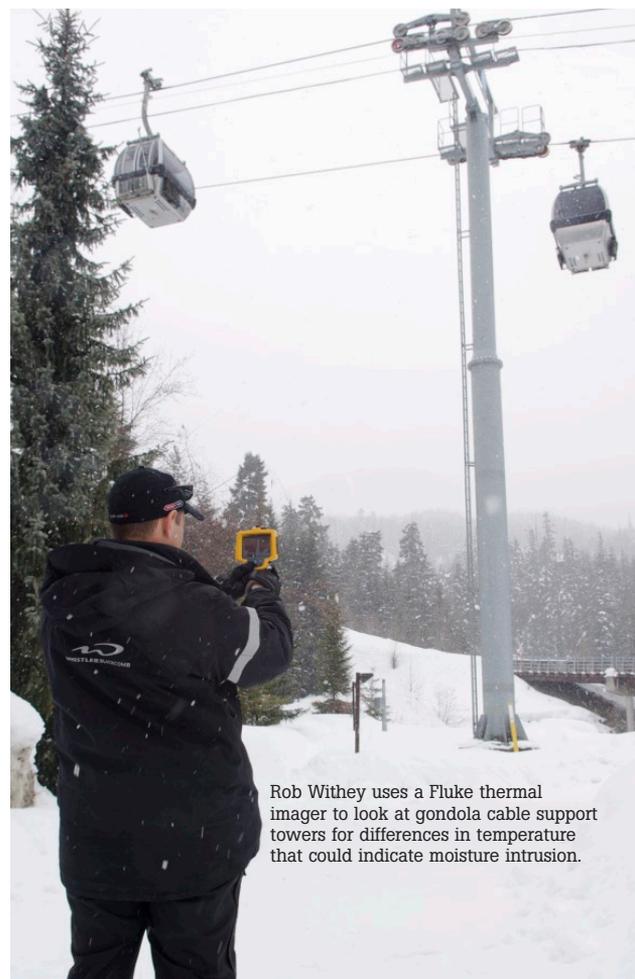
Rob Withey uses a Fluke thermal imager to look at gondola cable support towers for differences in temperature that could indicate moisture intrusion.

Towers are important parts of the ski lifts, and it's vital to make sure they're kept in good condition; here again the thermal imager proves its worth. Some towers are partly filled with

concrete, and if water were to find its way inside and then freeze it could cause damage. A concrete-filled tower shows a different thermal signature compared to an empty one, so one routine maintenance check is to take a thermal image of each tower. As long as a tower has all the same thermal "color" it means that it's okay. This kind of measurement would be difficult and quite time-consuming by any other method; with the thermal imager it's a snap.

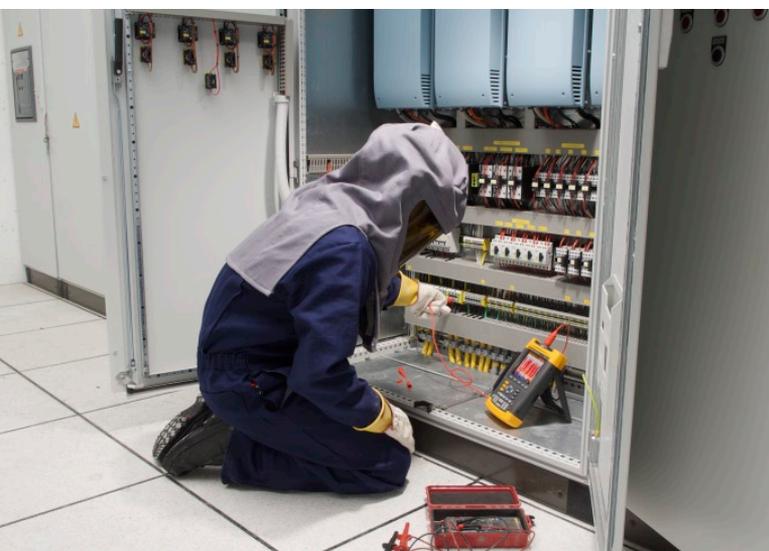
Rob Withey uses a Fluke ScopeMeter to check the output voltage that drives Peak 2 Peak conveyor motors.

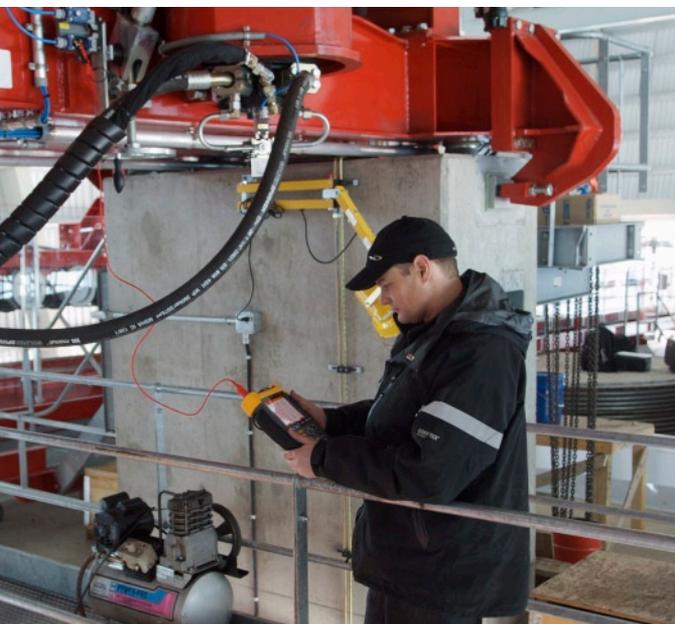
The Whistler/Blackcomb Peak 2 Peak gondola has many safety and redundant electrical systems. Rob Withey uses a Fluke ScopeMeter to look for voltage drop at a switch.
